**Flood Control Project Maintenance  
Levee Inspections**

**Fall 2010 Levee Maintenance Deficiency Summary Report**

**Reclamation District No. 2031 Elliot**

**Levee Inspection Report By Mile - Fall 2010**

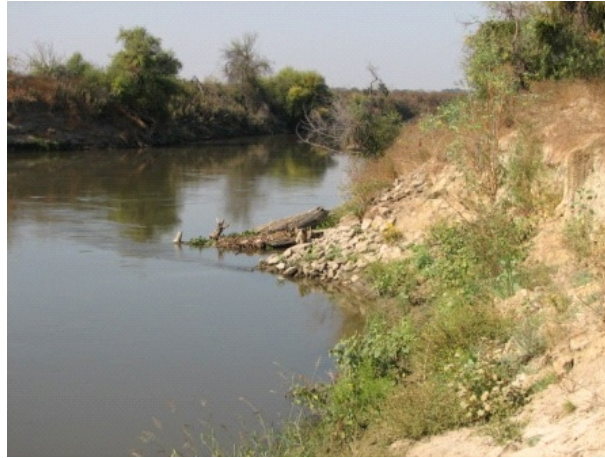
SJR2010\_RM78.70U2LM4.35RBd.jpg

Levee Mile Report Line	7
Start Levee Mile	4.33
End Levee Mile	4.37
Location	Water Side
Category	Supplemental
Item	DWR Erosion Survey
